Little Truckee River Assessment

Sierraville Diversion to Stampede Reservoir

Balance
Hydrologics, Inc.

March 19, 2014

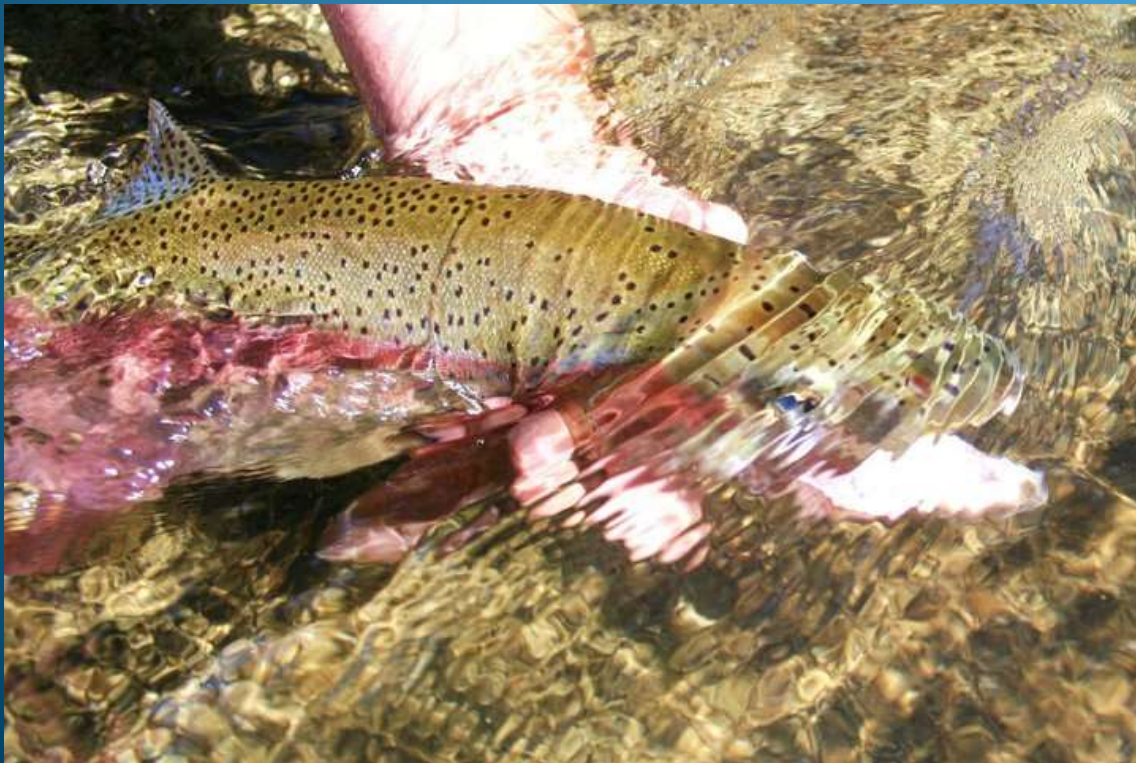
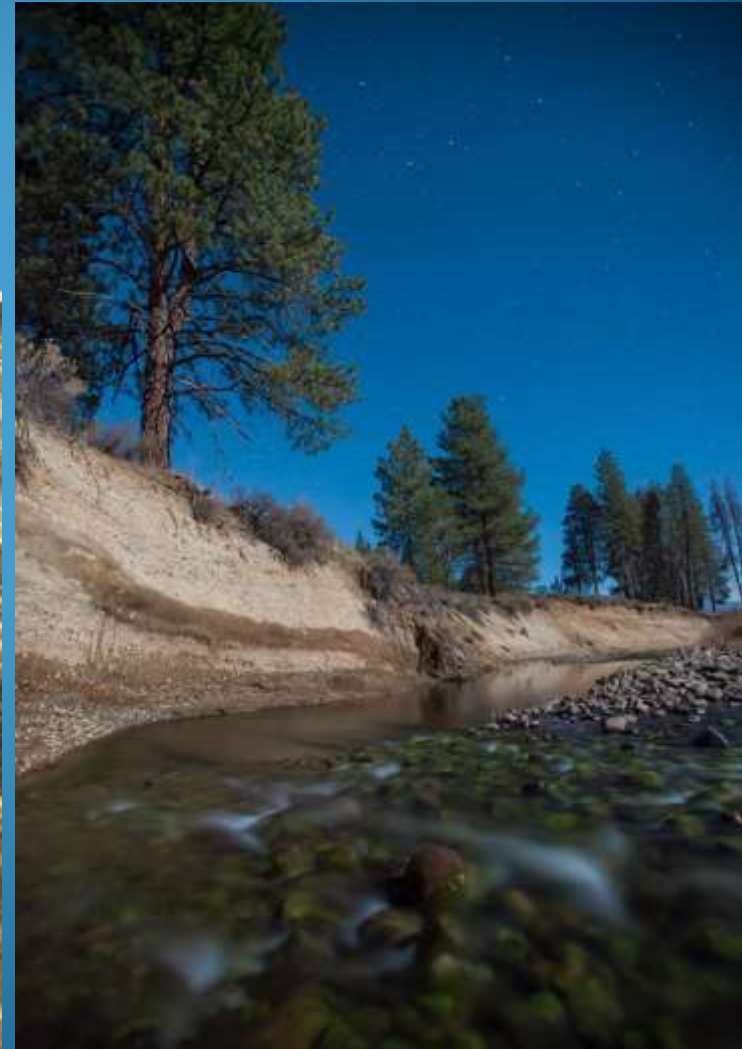
Assessment Methods – Vegetation Survey

Vegetation surveys for the inner
riparian zone

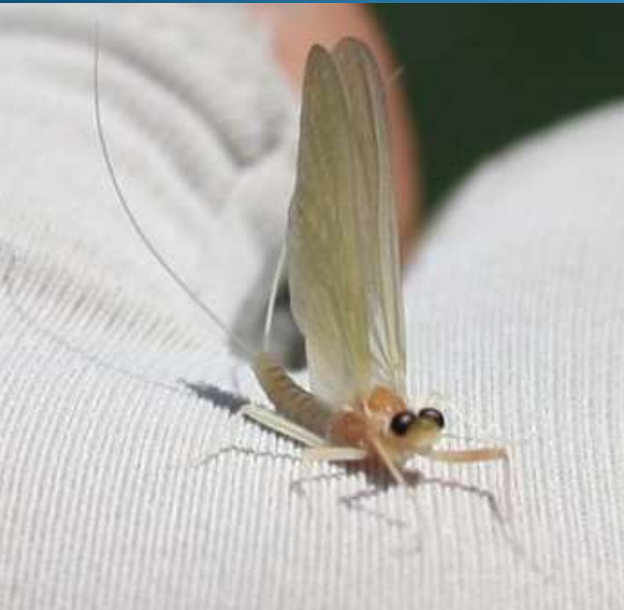
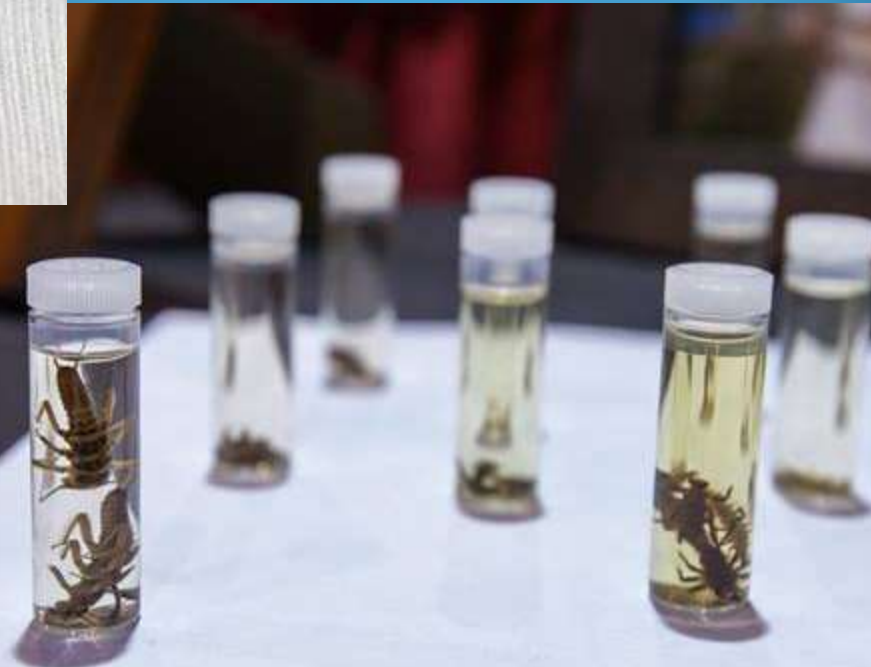
Assessment Methods – Fish and Macroinvertebrate Survey

- 1) Timed visual encounter surveys (VESs)
- 2) Invertebrate samples using multi-habitat sampling methods
- 3) Sent to the Aquatics Ecosystems Analysis Laboratory at UNR for sorting and identification

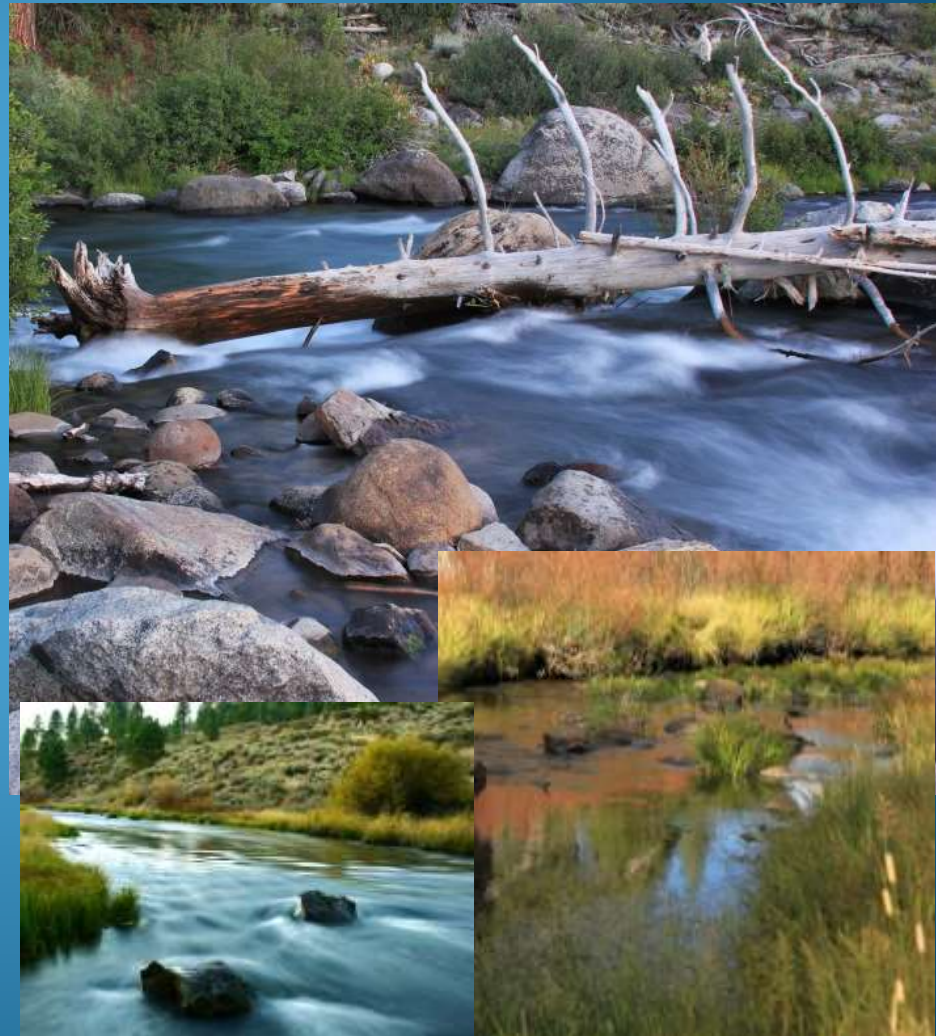
Assessment Methods— USFS Stream Inventory Survey

Surveys conducted September
26-29, 2013

- 1) Conducted one to two
surveys in each channel
reach
- 2) Survey at each “Channel
Unit”

*Other Measurements: *Substrate, Wolman Pebble Counts,
and Channel Alterations, Shade, Water Quality, Streamflow,
Aquatic Biota, Data Analysis*

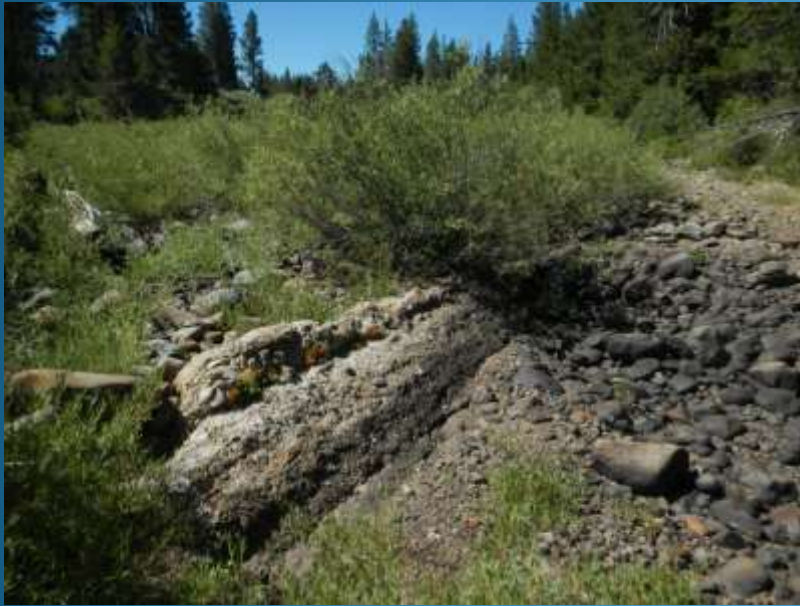
-Abundant sediment supply

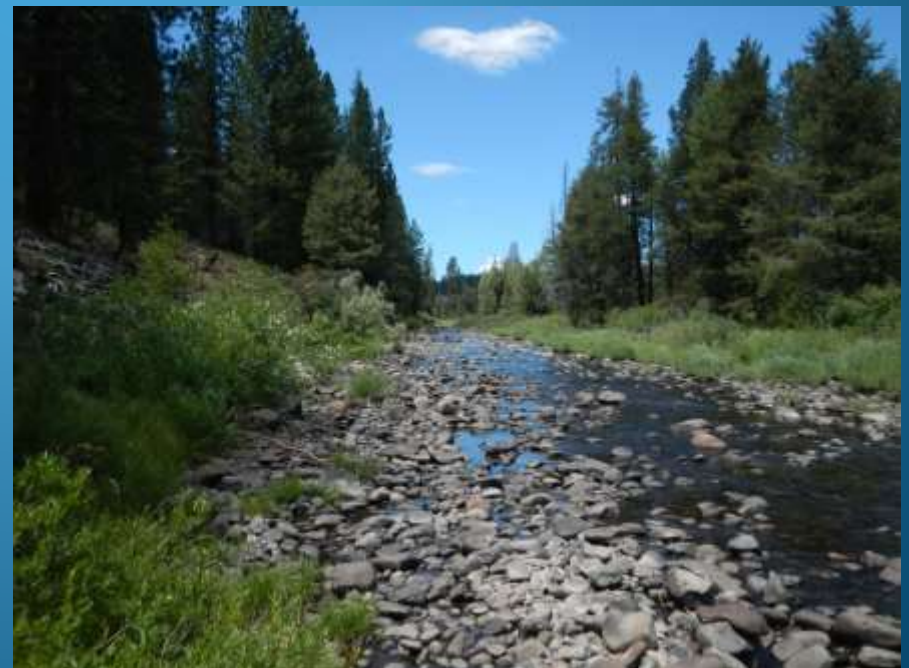
-Absence of instream wood

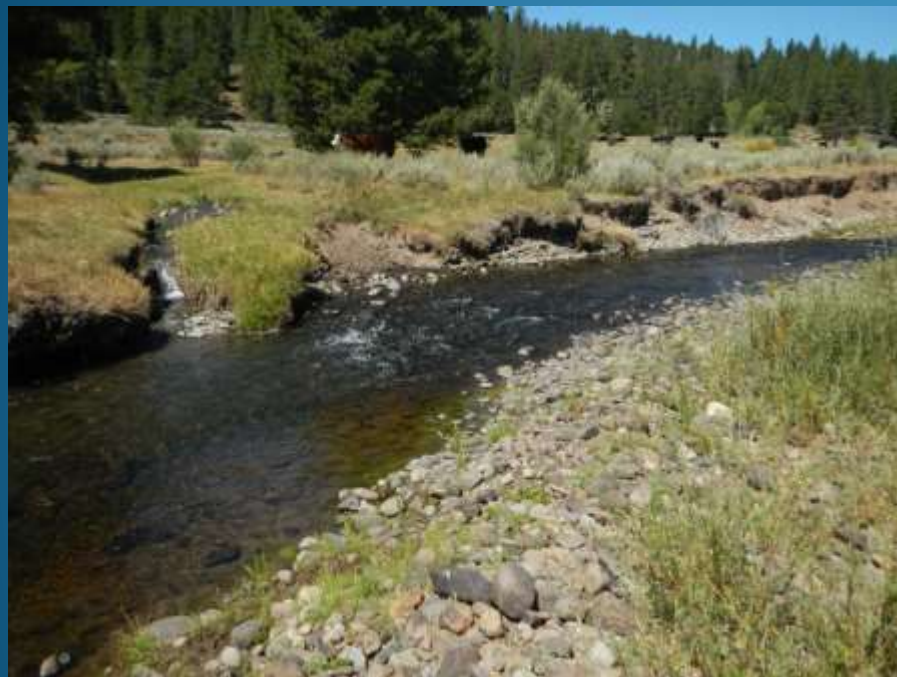
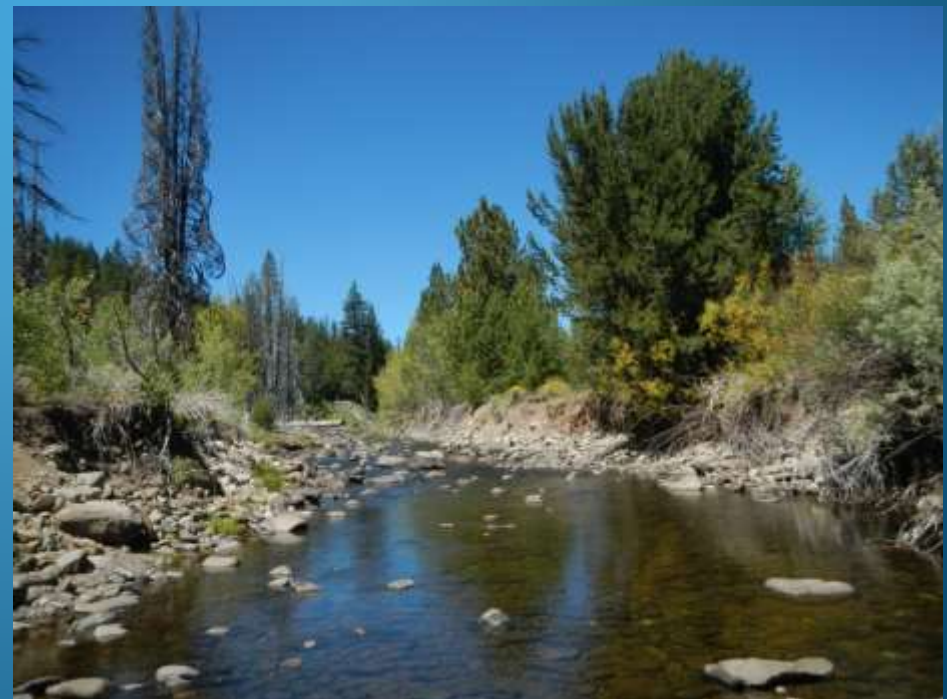
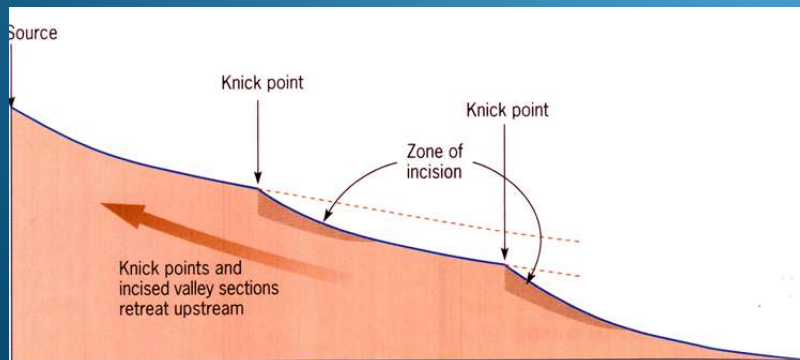
-Incising + widening channel

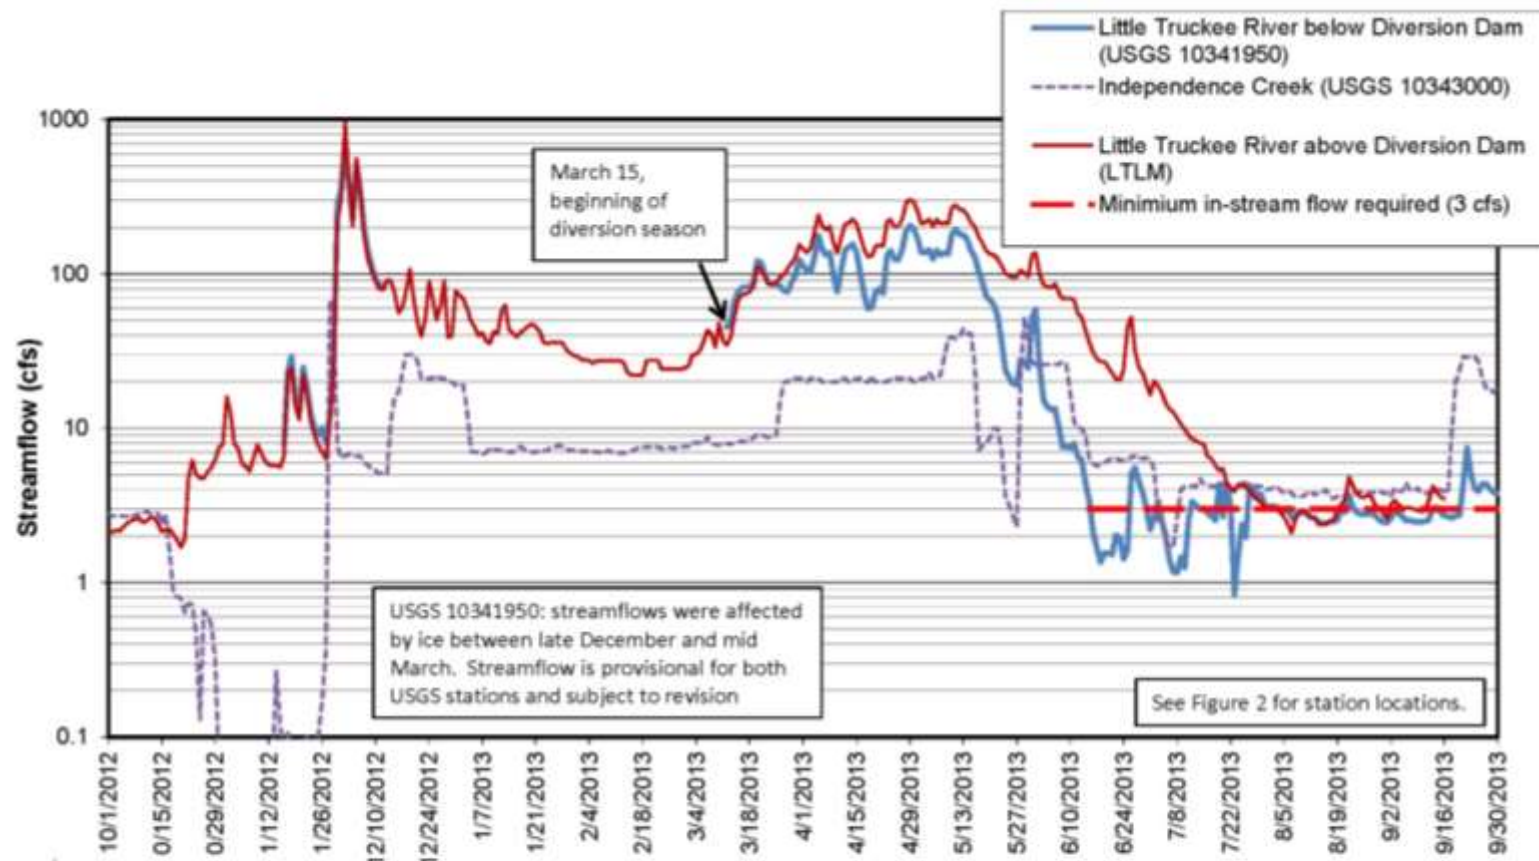
Figure 16. Daily Streamflow, Little Truckee River (above and below Diversion) and Independence Creek, Sierra County, California, WY2013 Recent gaging records below the Sierraville diversion suggest periods of time between June 15 and August 1, 2013 when instream flows requirements were not met. Streamflows receded rapidly through the summer and daily values were below 3 cfs at times upstream of the diversion (LTLM). Independence Creek provided additional baseflows during the summer and into the fall.

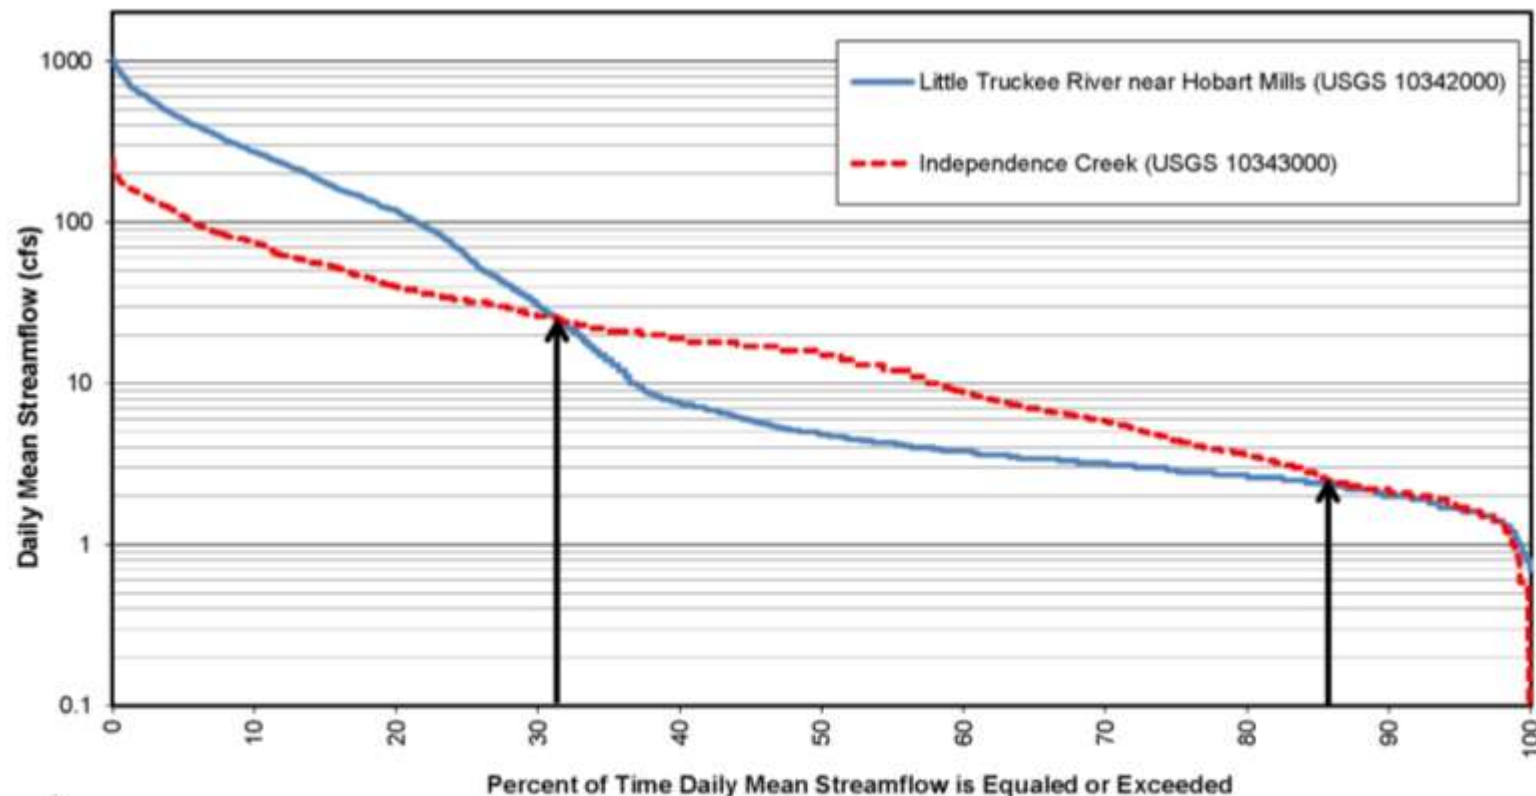
Figure 7. Baseflow Duration Curves, Little Truckee River above Independence Creek, and Independence Creek, Sierra County, California. Daily mean streamflows between June 1 and September 30 (baseflows) for each year were used for this analysis for each station's period of record. These data show that Independence Creek accounts for more than half (as high as 75 percent) of the total flow in the Little Truckee River during active diversion at Sierraville Dam. Furthermore, this occurs roughly 55 percent of the time between June and September of each year.

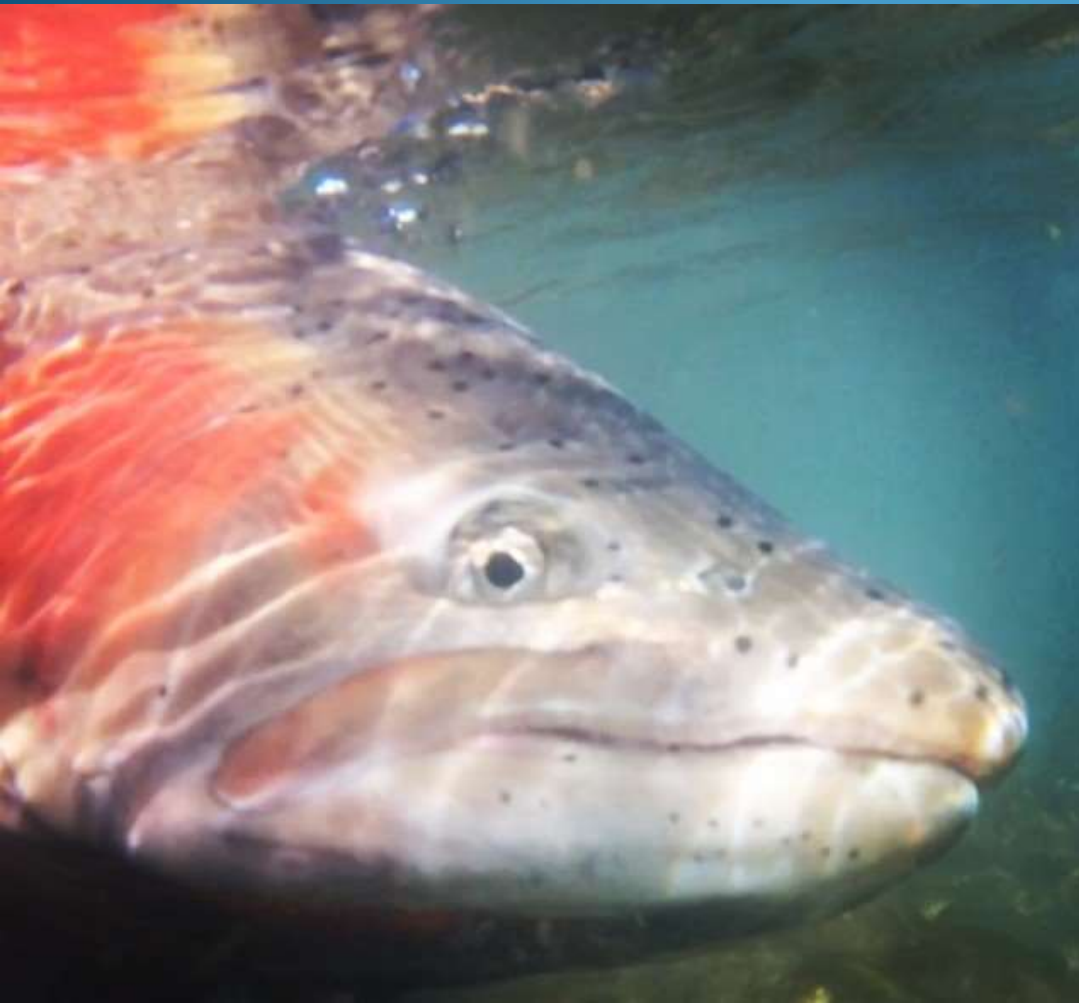
Fish Survey Results

Overall, presence, density and diversity of native and non-native game fishes are low throughout the study area, as compared to similar Sierra systems.
